**EVALUATION OF TREES AT THE  
SOUTHBAY CHRISTIAN CENTER  
539 E. WEDDELL DRIVE  
SUNNYVALE**

**Prepared by:  
Michael L. Bench  
Consulting Arborist  
August 4<sup>th</sup>, 2005**

**Job # 08-05-157 Site II**

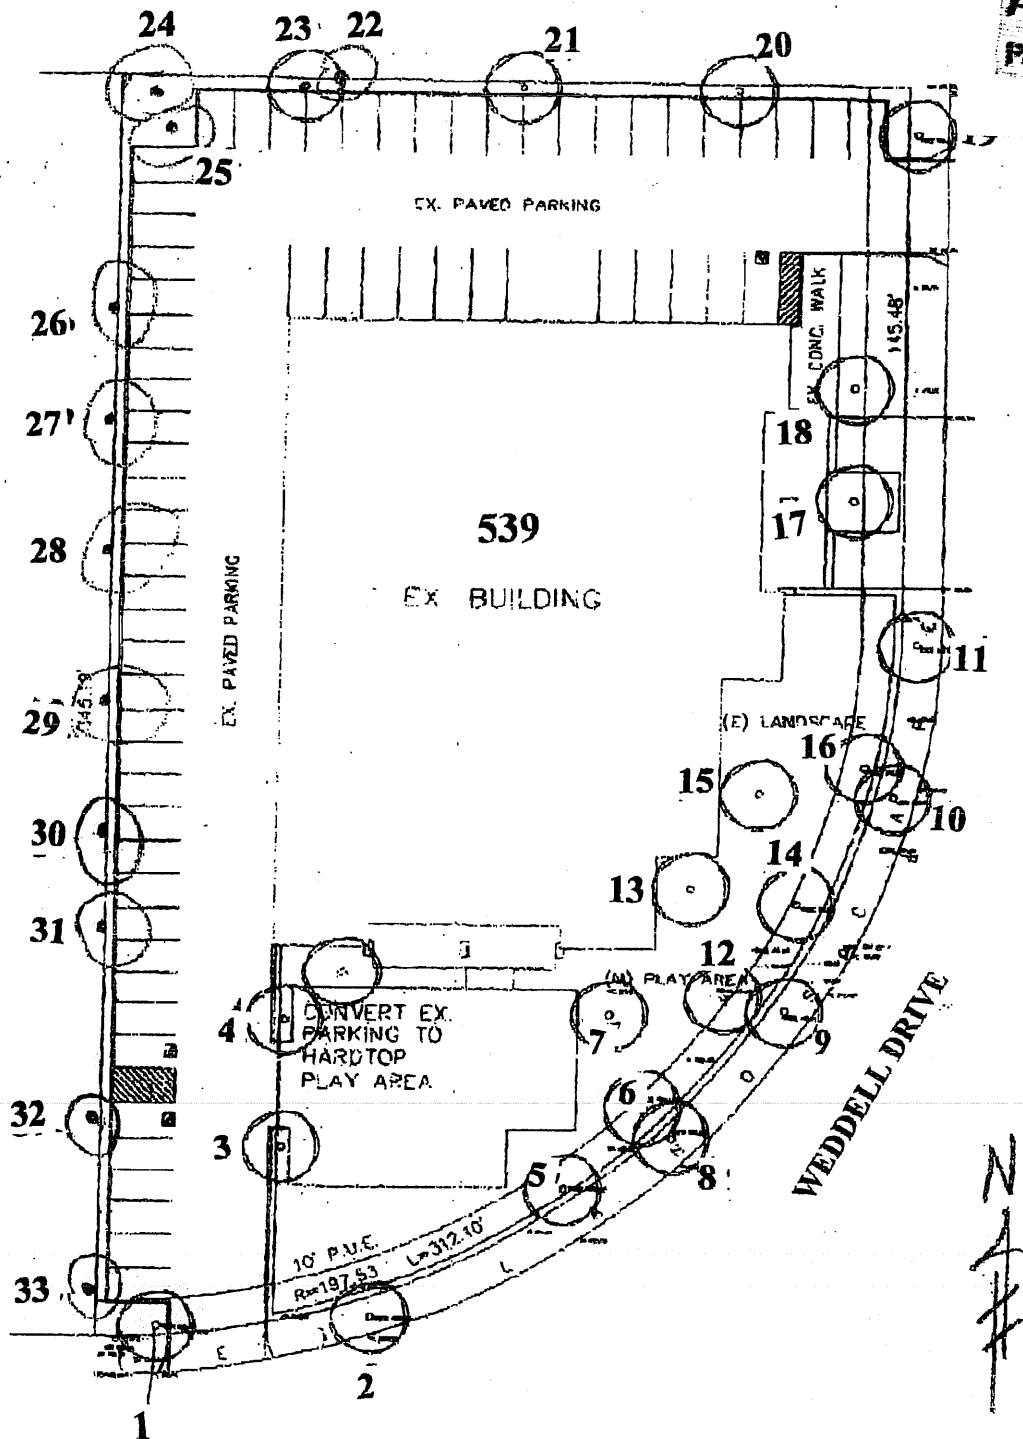
Some of the 34 trees were not shown on the map provided and have been added. Their locations are approximate. The attached map shows the estimated locations of all of these 34 trees and their approximate canopy dimensions.

Tree numbers correspond to evaluation charts.  
All dimensions and tree locations are  
approximate.
